**Flood Control Project Maintenance
Levee Inspections**
LMA District Cover Sheet
Spring 2018 Levee Inspection Results

Reclamation District No. 2075 McMullin

Waterway			Bank	Unit Miles
Unit No. 01 San Joaquin River			Right	7.45
	Spring (March - May)	Summer (June - August)	(September - November) Fall	Winter (December - February)
Unit Maintenance Rating (Fall Only)				
Date of Inspection	5/24/2018 - 5/24/2018			
DWR Inspector	Richard Willoughby			
Accompanied By	Loren Haworth			
	Brian Mizuno

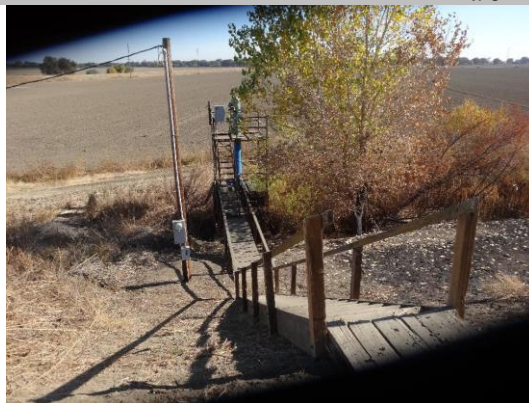
Photo 3 of 3 : UCIP_SP_2018_24663_44020.jpg

Comment Code						
Inspector Comment						
FS_ID:24663 DS_ID:24735 EP_NO: 4736 Repair Type: Non-Urgent Crossing Status: Found UCIP Comments: - pipe not visible on waterside.- no access to concrete riser on waterside.- blocked siphon breaker. FIELD_STRUCT_DESC: 14-inch coated steel drainage discharge pipe through the levee, 4 feet below the crown. Two concrete cutoff walls. Pump mounted on a pile structure in the drainage ditch on the landside (LS). Siphon breaker in a concrete riser on the waterside (WS) slope. Concrete distribution box at the WS toe. (Plans for removing and replacing an existing drainage pipe through the levee authorized under Permit No. 4736, 1964 - Reclamation District No. 2075). [Additional Reference(s): DWR Levee Log, 2005, 12-inch pipe referenced. USACE San Joaquin O&M Manual 3, December 1968, (HLM 0.12), 12-inch pipe referenced]. FS Date: 11/13/2013

LS view: walkway, pump, service pole, and intake structure.

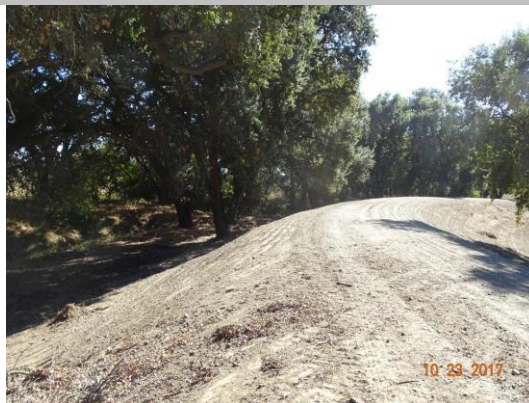
Photo 1 of 1 : SP_2018_RD2075_315_13_20180503_00008.jpg

LM Start	0.99	Rating **	A/W	Issue No.	13
LM End	1.00	Issue Type +	Ma	Location *	LS
Category	Earthen Levee			GPS Latitude/Longitude	
				Start	End
Item	Trim / Thin Trees			37.740015 °	37.739830 °
				-121.281243 °	-121.281217 °
DWR ID	DWR_RD2075_01_f_2016_13				
Comment Code					
T4 : Trim trees over roadway to at least 12 feet above ground level.					
Inspector Comment					
Trees have been trimmed to allow inspection and access.

Trees have been trimmed to allow inspection and access.

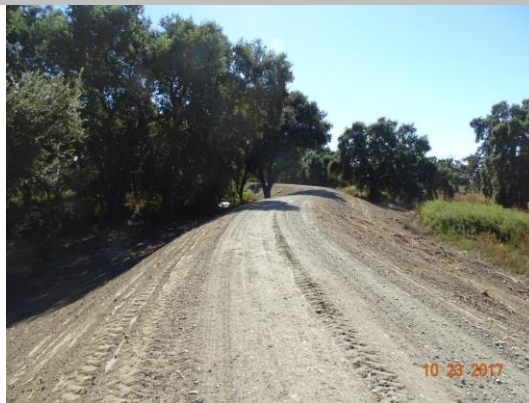
Photo 1 of 1 : SP_2018_RD2075_315_17_20180503_00021.jpg

Trees trimmed to allow inspection and access.

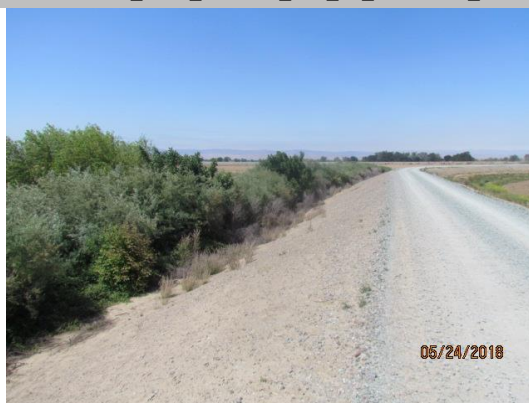
Photo 1 of 3 : SP_2018_RD2075_315_29_20180525_00065.jpg

LM Start	1.55	Rating **	U	Issue No.	29
LM End	1.63	Issue Type +	Ma	Location *	LS
Category	Earthen Levee			GPS Latitude/Longitude	
				Start	End
Item	Vegetation			37.734470 °	37.734213 °
				-121.286230 °	-121.287660 °
DWR ID	DWR_RD2075_01_s_2018_29				
Comment Code					
V2 : Remove the wild growth other than native grasses from the levee slopes.					
Inspector Comment					
Wild growth at landward toe blocking view and should cleared fifteen feet for landward toe.

Looking west at dense veg at landward toe. (Spring 2018)

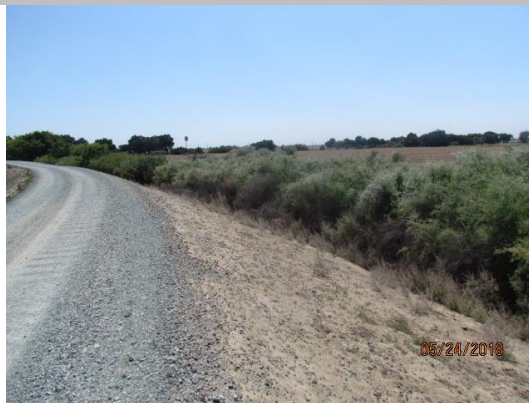
Photo 3 of 3 : SP_2018_RD2075_315_29_20180525_00066.jpg

Looking northeast at dense veg at landward toe. (Spring 2018)

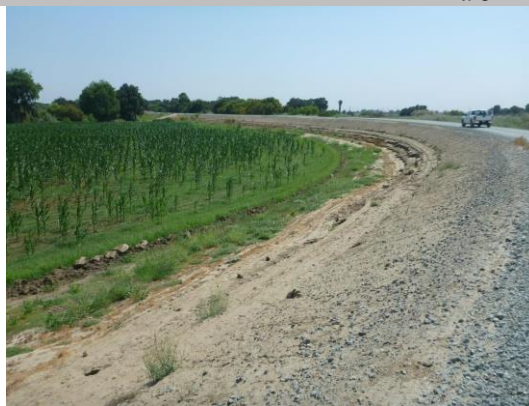
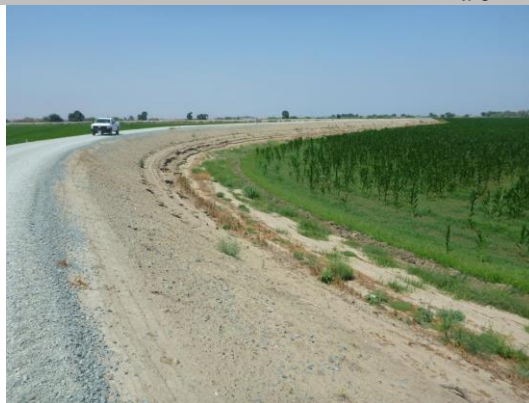
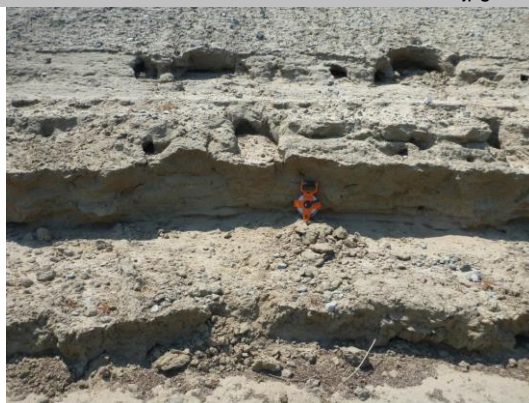
Comment Code					
Inspector Comment					
Levee Evaluation Comments					
Description:Slope protection repairs are needed along the waterside slope due to erosion and riprap displacement from high water. Based upon levee inspections, it was determined the waterside levee slope is eroding, deteriorating, and degrading. The eroded levee sections need to be restored back to design standards to prevent further deterioration and damage.					
Site ID No:575					
Site Designation:LMA-481					
Repair Type: Erosion					
Rating:Area of Concern					
Field Date:8/10/2017					
Notes: 10/23/17: According to LMA and my observations at LM 1.63, this site never had riprap (contrary to previous comments). Erosion has encroached into levee prism. Future high water and wavewash will likely advance erosion further into prism. Repairs should be made prior to next high water.

Description: Slope protection repairs are needed along the waterside slope due to erosion and riprap displacement from high water. Based upon levee inspections, it was determined the waterside levee slope is eroding, deteriorating, and degrading. The eroded levee sections need to be restored back to design standards to prevent further deterioration and damage.

Notes: 10/23/17: According to LMA and my observations at LM 1.63, this site never had riprap (contrary to previous comments). Erosion has encroached into levee prism. Future high water and wavewash will likely advance erosion further into prism. Repairs should be made prior to next high water.

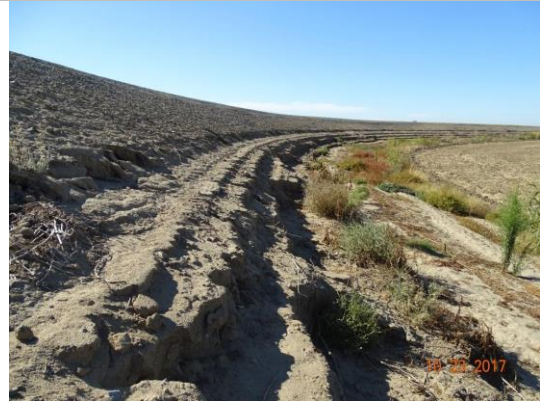
Photo 4 of 4 : SP_2018_RD2075_315_12_20180503_00007.jpg

10/23/17: According to LMA and my observations at LM 1.63, this site never had riprap (contrary to previous comments). Erosion has encroached into levee prism. Future high water and wavewash will likely advance erosion further into prism. Repairs should be made prior to next high water.

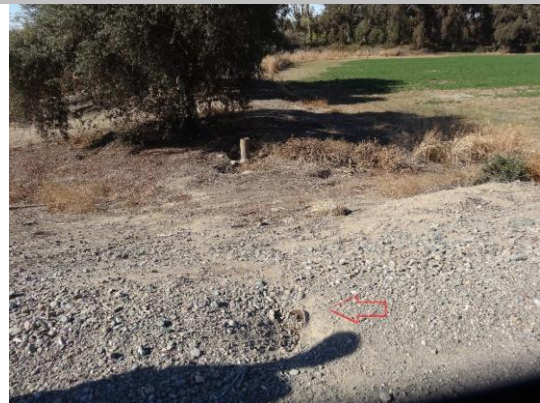
Photo 1 of 3 : UCIP_SP_2018_24666_45600.jpg

LM Start	2.32	Rating **	M	Issue No.	31
LM End	2.32	Issue Type +	Ma	Location *	
Category	Supplemental			GPS Latitude/Longitude	
				Start	End
Item	DWR UCIP LMA Responsibility			37.731314 °	37.731314 °
				-121.293713 °	-121.293713 °
DWR ID					
Comment Code					
Inspector Comment					
FS_ID:24666 DS_ID:24737 EP_NO: N/A Repair Type: Non-Urgent Crossing Status: Found UCIP Comments: - service pole on landside.- looks abandoned. Walkway in dilapidated condition. FIELD_STRUCT_DESC: 16-inch steel drainage discharge pipe through the levee, 4.5 feet below the crown. Corrugated metal cutoff wall. Pump mounted on a pile structure in a drainage ditch on the landside (LS). Siphon breaker in a corrugated metal pipe (CMP) riser on the waterside (WS) slope. [Additional Reference(s): DWR Levee Log, 2005. USACE San Joaquin O&M Manual 3, December 1968, (HLM 2.30)]. FS Date: 11/13/2013

WS view: concrete standpipe (top) and steel pipe riser (bottom marked) on levee slope.

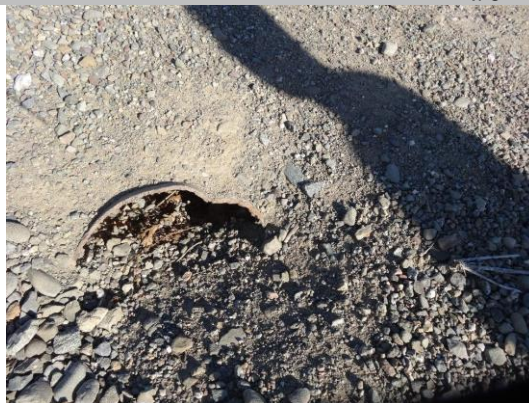
Photo 2 of 3 : UCIP_SP_2018_24666_44030.jpg

WS view: blocked siphon breaker in steel pipe riser on levee slope.

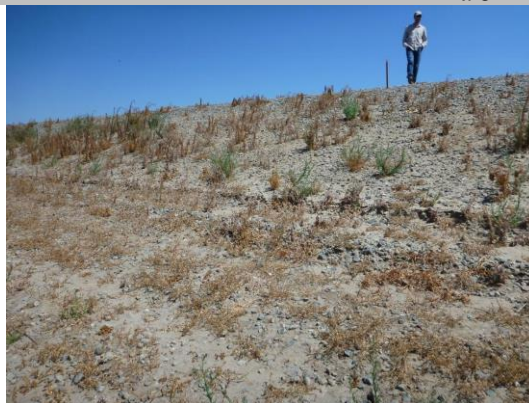
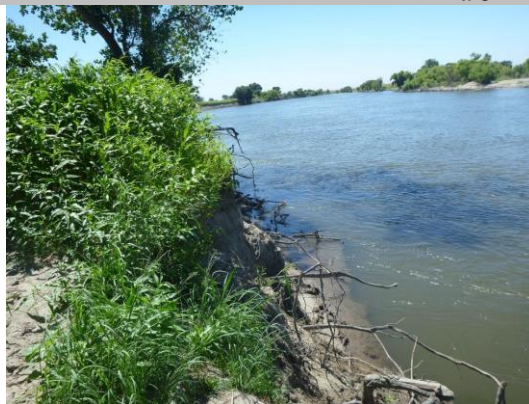
Comment Code					
Inspector Comment					
Levee Evaluation Comments					
Description:Slope protection repairs are needed along the waterside slope due to erosion. Based upon levee inspections, it was determined the waterside levee slopes were eroding, deteriorating and degrading in concave pocket sections at various locations along this levee reach. The eroded levee sections need to be restored back to design standards to prevent further deterioration of the damaged levee sections.					
Site ID No:480					
Site Designation:LMA-307					
Repair Type: Erosion					
Rating:Area of Concern					
Field Date:7/26/2017					
Notes: Low priority because of the wide berm. Could not see all of the bank because of vegetation. Rock was placed on LS here during this years storms.

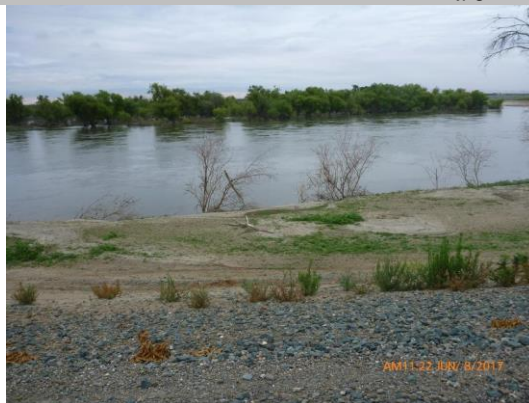
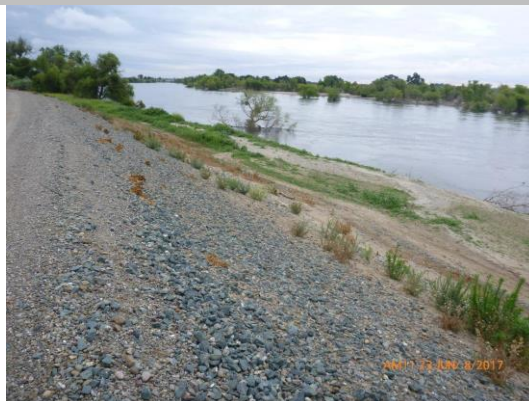
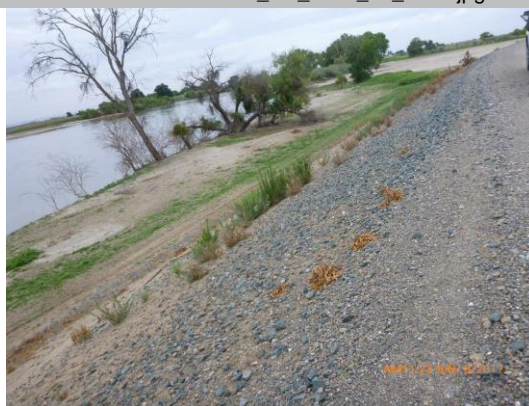
LM Start	2.77	Rating **	A/W	Issue No.	14
LM End	2.83	Issue Type +	Ma	Location *	
Category	Supplemental			GPS Latitude/Longitude	
				Start	End
Item	2017 Storm Damage			37.724810 °	37.724207 °
				-121.294150 °	-121.293308 °
DWR ID	DWR_RD2075_01_f_2017_14				
Comment Code					
Inspector Comment					
Levee Evaluation Comments					
Description:					
Site ID No:81					
Site Designation:LMA-35					
Repair Type: Erosion					
Rating:Area of Concern					
Field Date:6/8/2017					
Notes: no damage present 10/23/17: Photos taken of vertical eroded low-flow bank approximately 20 feet from waterside levee toe. Area is composed of loose sand. Sandbar in channel may direct current toward this area.

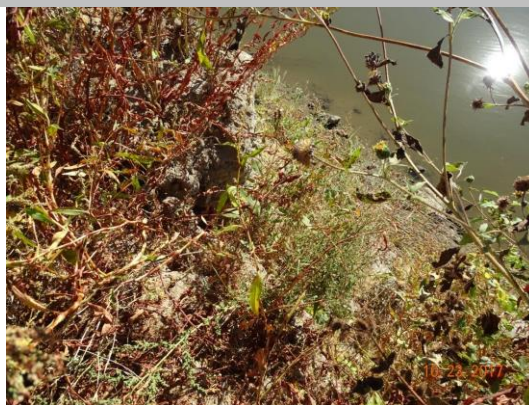
Photo 4 of 6 : SP_2018_RD2075_315_14_20180503_00012.jpg

View down through erosion rut in bank. 10/23/17: Photos taken of vertical eroded low-flow bank approximately 20 feet from waterside levee toe. Area is composed of loose sand. Sandbar in channel may direct current toward this area.

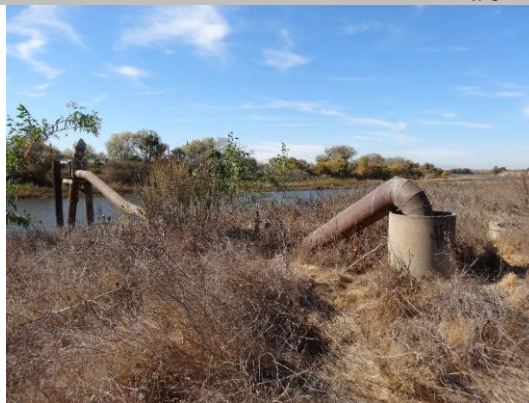
Photo 1 of 3 : UCIP_SP_2018_41721_45982.jpg

Comment Code						
Inspector Comment						
FS_ID:41721						
DS_ID:24746						
EP_NO: N/A						
Repair Type: Non-Urgent						
Crossing Status: Found						
UCIP Comments: Several concrete structure with Alfalfa valve. Only steel pipe visible on river bank. Service pole on waterside.New field discovered crossing.						
FIELD_STRUCT_DESC: 10-inch polyvinyl chloride (PVC) irrigation discharge pipe through the levee, at an unknown depth. Slant pump on the riverbank. Distribution box on the waterside (WS) berm. Concrete U-shaped headwall and open outlet on the landside (LS) toe. Crossing was field discovered. (Plans to install a slant pump on the riverbank authorized under Permit No. 5484, 1966 - Jack Clinton).						
FS Date: 11/13/2013

WS view: slant pump and concrete distribution box on levee berm.

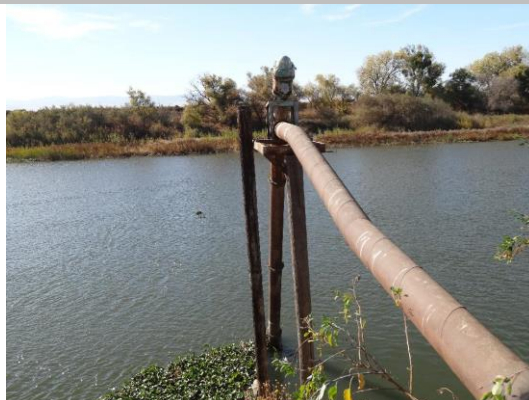
Photo 2 of 3 : UCIP_SP_2018_41721_45981.jpg

WS view: slant pump on timber pile in the stream.

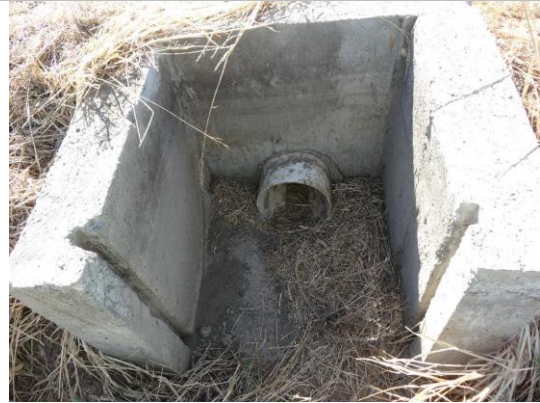
Photo 3 of 3 : UCIP_SP_2018_41721_45980.jpg

LS view: concrete U type headwall on levee toe and open PVC pipe.

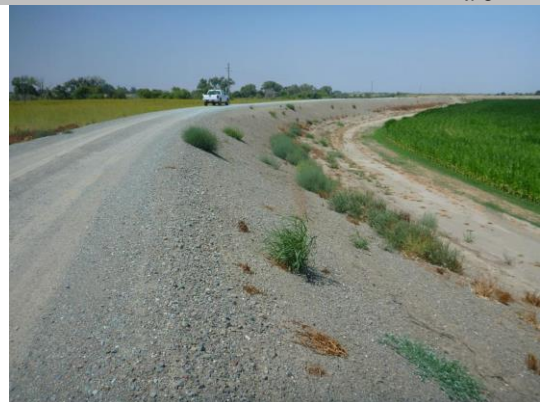
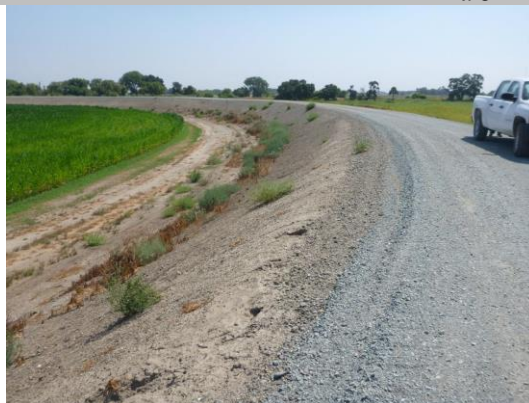
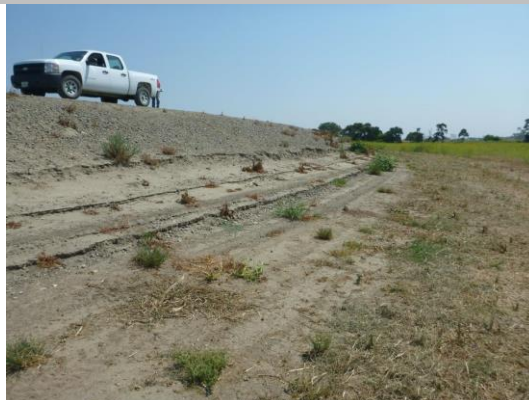
Comment Code					
Inspector Comment					
Levee Evaluation Comments					
Description:Slope protection repairs are needed along the waterside slope due to erosion and riprap displacement from high water. Based upon levee inspections, it was determined the waterside levee slope is eroding, deteriorating, and degrading. The eroded levee sections need to be restored back to design standards to prevent further deterioration and damage.					
Site ID No:576					
Site Designation:LMA-482					
Repair Type: Erosion					
Rating:Area of Concern					
Field Date:8/10/2017					
Notes: 10/23/17: There was no riprap in this area. Erosion sites have been repaired by LMA.

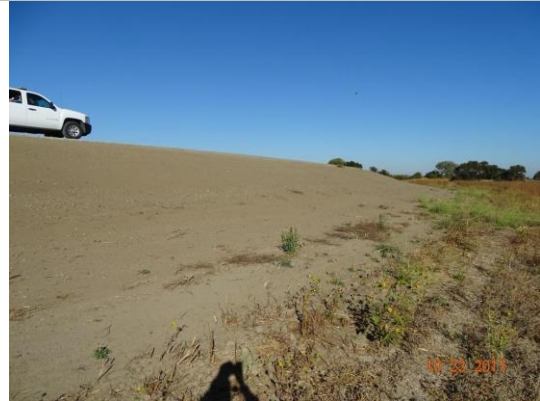
Photo 4 of 4 : SP_2018_RD2075_315_18_20180503_00025.jpg

10/23/17: There was no riprap in this area (contrary to previous comment). Erosion sites have been repaired by LMA.

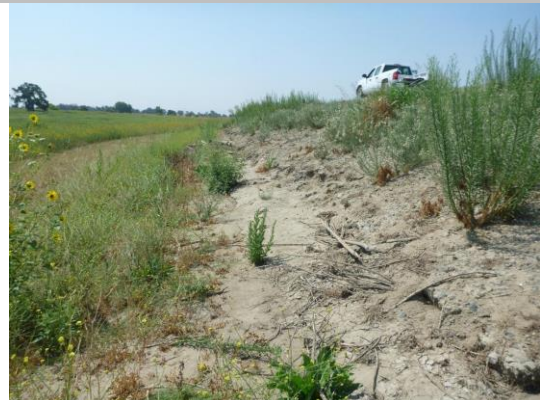
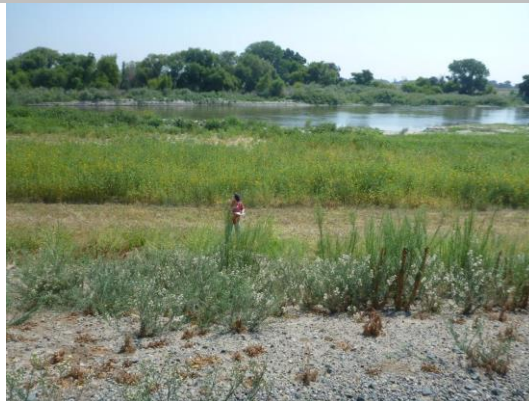
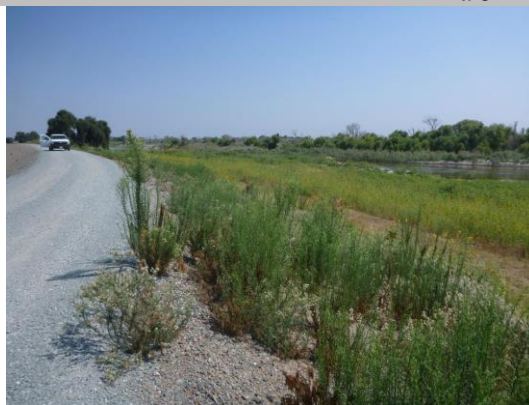
Item	2017 Storm Damage		37.714048 °	37.714630 °								
			-121.278363 °	-121.278263 °								
DWR ID	DWR_RD2075_01_f_2017_19											
Comment Code												
Inspector Comment												
<p>Levee Evaluation Comments</p> <p>Description: Slope protection repairs are needed along the waterside slope due to erosion and riprap displacement from high water. Based upon levee inspections, it was determined the waterside levee slope is eroding, deteriorating, and degrading. The eroded levee sections need to be restored back to design standards to prevent further deterioration and damage.</p> <p>Site ID No: 577</p> <p>Site Designation: LMA-483</p> <p>Repair Type: Erosion</p> <p>Rating: Area of Concern</p> <p>Field Date: 8/10/2017</p> <p>Notes:</p>

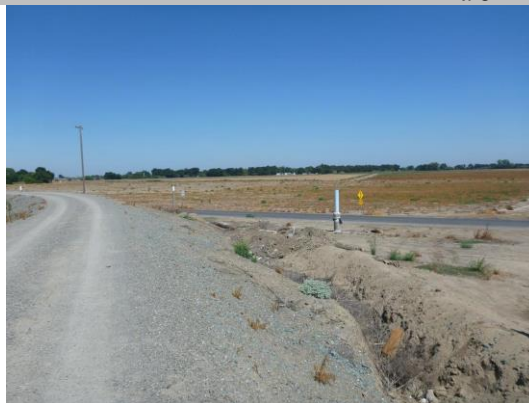
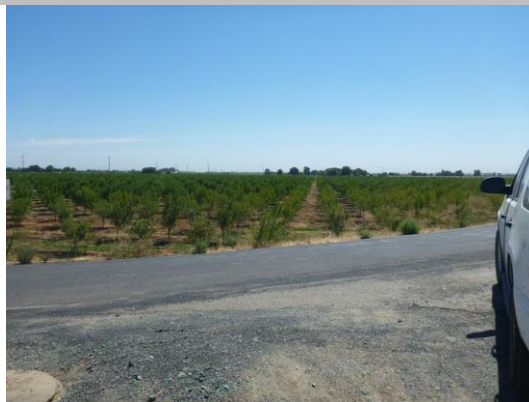
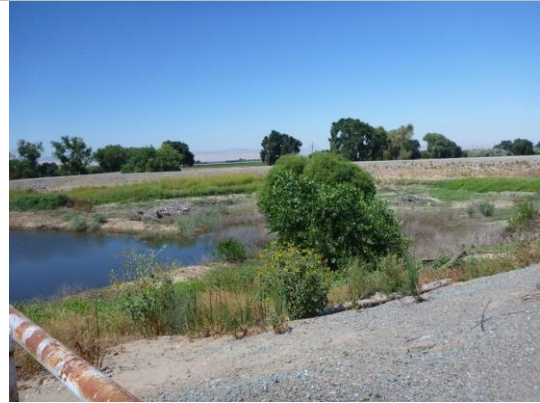
LM Start	4.95	Rating **	A/W	Issue No.	20
LM End	5.20	Issue Type +	Ob	Location *	
Category	Supplemental			GPS Latitude/Longitude	
				Start	End
Item	2017 Storm Damage			37.727200 °	37.728900 °
				-121.277800 °	-121.275200 °
DWR ID	DWR_RD2075_01_f_2017_20				
Comment Code					
Inspector Comment					
Levee Evaluation Comments					
Description:Heavy seepage was observed during the high water this year.					
Site ID No:481					
Site Designation:LMA-308					
Repair Type: Seepage					
Rating:Area of Concern					
Field Date:7/26/2017					
Notes: No evidence of flood fight here, but the orchard trees next to the levee are looking a little yellow compared to the others.

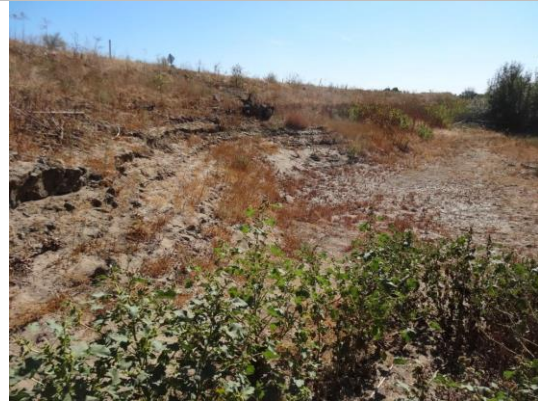
Photo 3 of 3 : SP_2018_RD2075_315_1_20180503_00003.jpg

Looking upstream at the site.

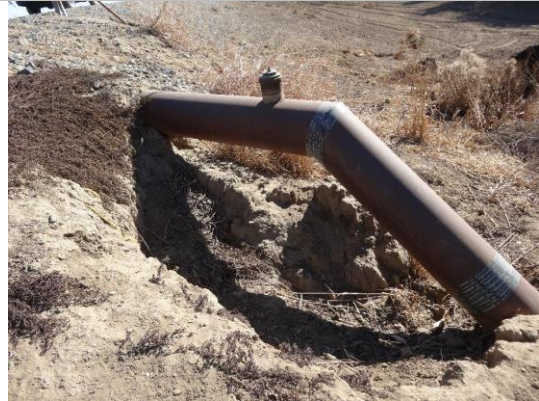
Photo 1 of 3 : UCIP_SP_2018_50191_44262.jpg

WS view: siphon breaker on steel pipe on levee slope. Huge soil erosion due to siphon breaker leakage.

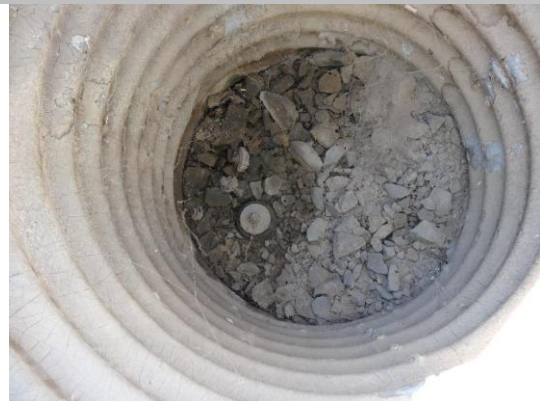
Photo 2 of 3 : UCIP_SP_2018_50213_45612.jpg

WS view: siphon breaker in CMP riser on levee shoulder.

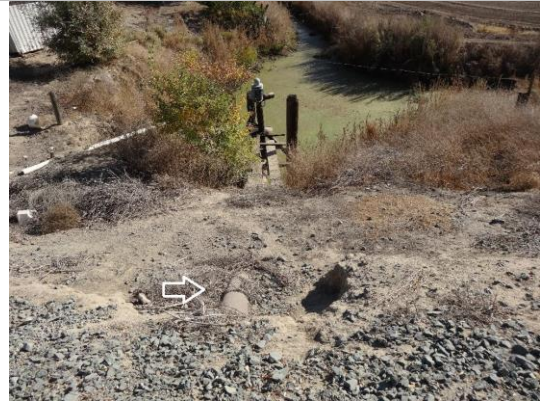
Photo 3 of 3 : UCIP_SP_2018_50213_45614.jpg

LS view: deformed pipe and soil erosion around it (marked bottom). Pipe and pump on pile structure in drain ditch.
